Manhole Inspection Summary

Manhole # S45MM_014MH

Inspection ☐ Is Incomplete Rating: **3) Fair**

Insp Date: **3/24/08 1:03 PM**

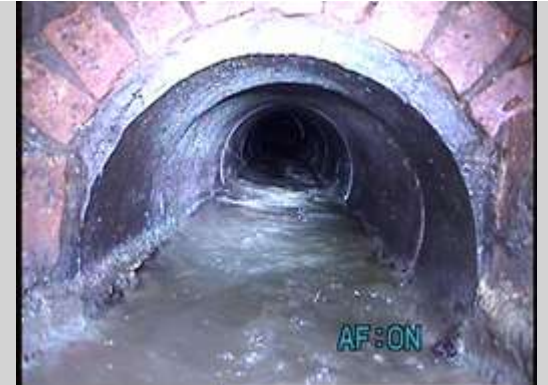
12 O'Clock Outflow

18 in. Circular Gravity Sewer
Pipe Out @ 12 O'Clock

Pipe Height: **16.8** (in.) Rod and Bar (Angled)
Pipe Material: **Clay** ☐ Pipe Lined
Invert Depth: **9.40** (ft.) Flow Characteristics: **Turbulent**
Deposits: ☒ None ☐ Mud ☐ Sludge ☐ Debris ☐ Grease
Silt Depth: (in.) Deposits Extent:
Infiltration: **None** Pipe Seal Cond: **Sound**

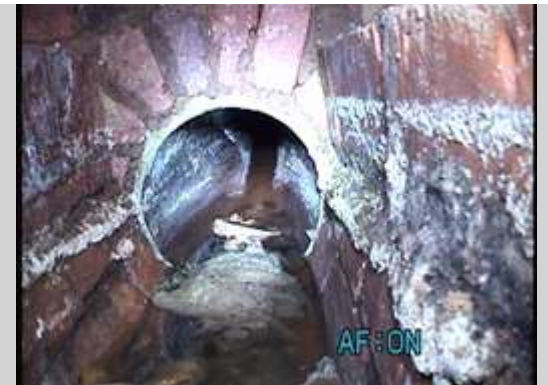
6 O'Clock Inflow

8 in. Circular Gravity Sewer
Pipe In @ 6 O'Clock

Pipe Height: **8.4** (in.) Rod and Bar (Angled)
Pipe Material: **Clay** ☐ Pipe Lined
Invert Depth: **8.80** (ft.) Flow Characteristics: **None**
Deposits: ☒ None ☐ Mud ☐ Sludge ☐ Debris ☐ Grease
Silt Depth: (in.) Deposits Extent:
Infiltration: **None** Pipe Seal Cond: **Sound**

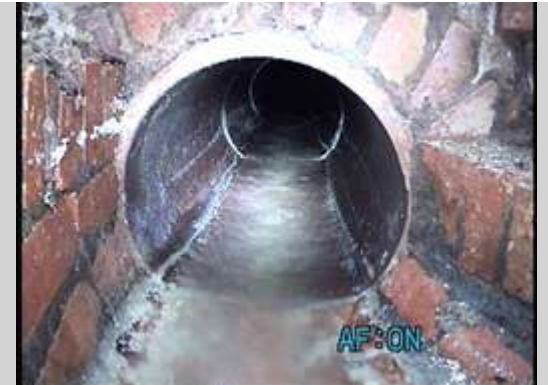
9 O'Clock Inflow

12 in. Circular Gravity Sewer

Pipe In @ 9 O'Clock

Pipe Height: **13.2** (in.) Rod and Bar (Angled)

Infiltration: **None** Pipe Seal Cond: **Sound**
